AN INVESTIGATION OF A THERMAL ICE-PREVENTION SYSTEM
FOR A C-46 CARGO AIRPLANE

VII - EFFECT OF THE THERMAL SYSTEM ON THE
WING-STRUCTURE STRESSES AS ESTABLISHED IN FLIGHT

By Alun R. Jones and Bernard A. Schlaff

Ames Aeronautical Laboratory
Moffett Field, California

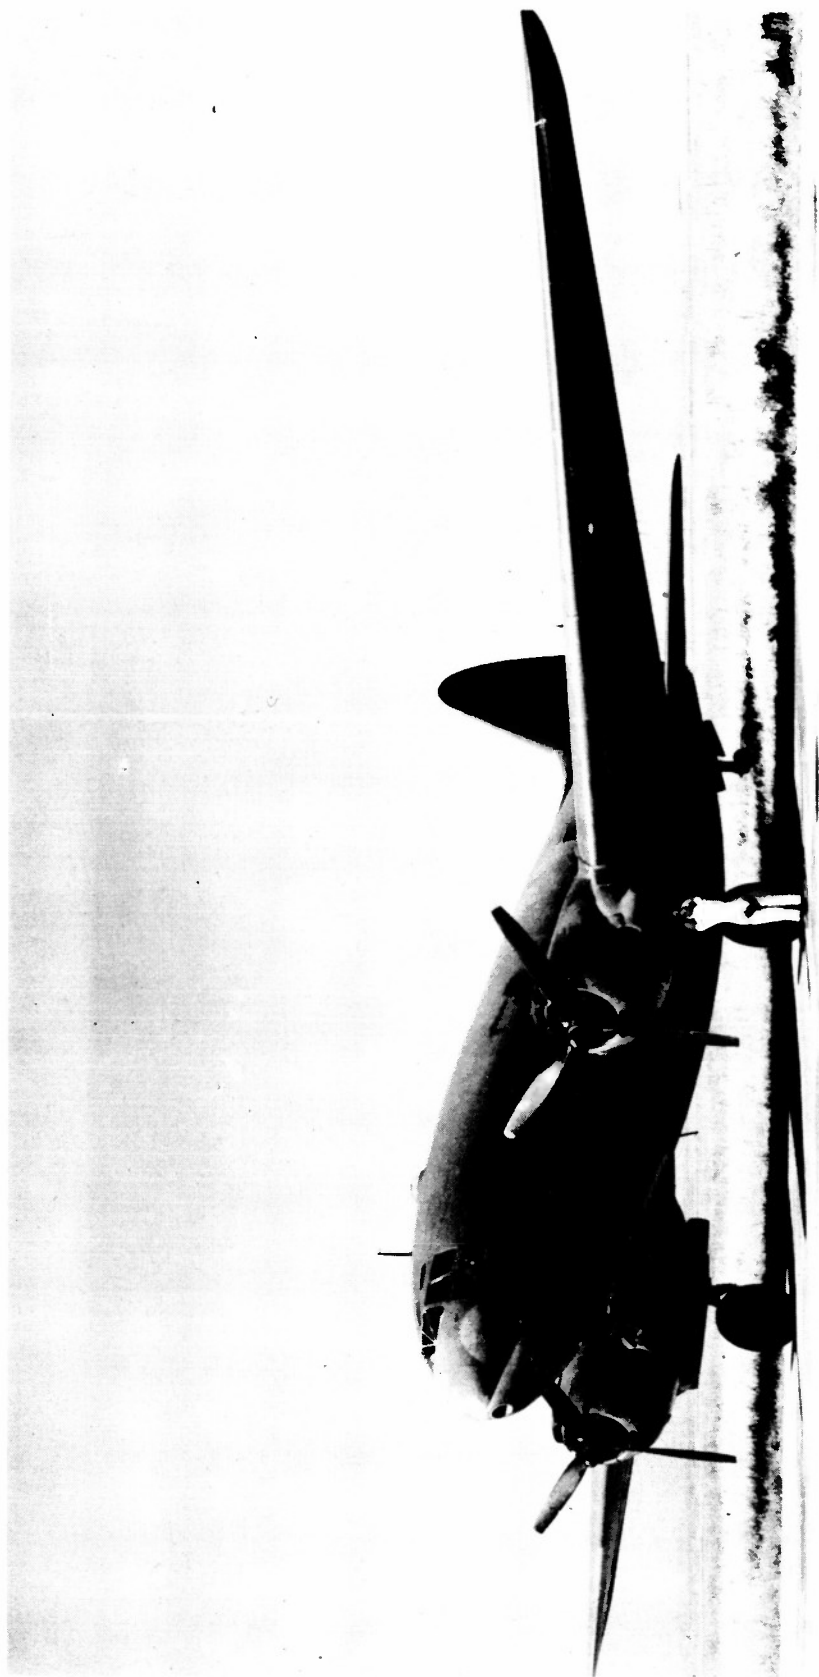
Figure 1.- The C-46 airplane equipped with a thermal ice-prevention system.

The C-46 airplane (fig. 1) is a twin-engine, low-wing, transport-cargo monoplane powered by Pratt & Whitney model R-2800-51 engines having a sea-level rating of 2000 horsepower each. The wing span is 108 feet, the wing area 1360 square feet, and the normal gross weight 45,000 pounds.

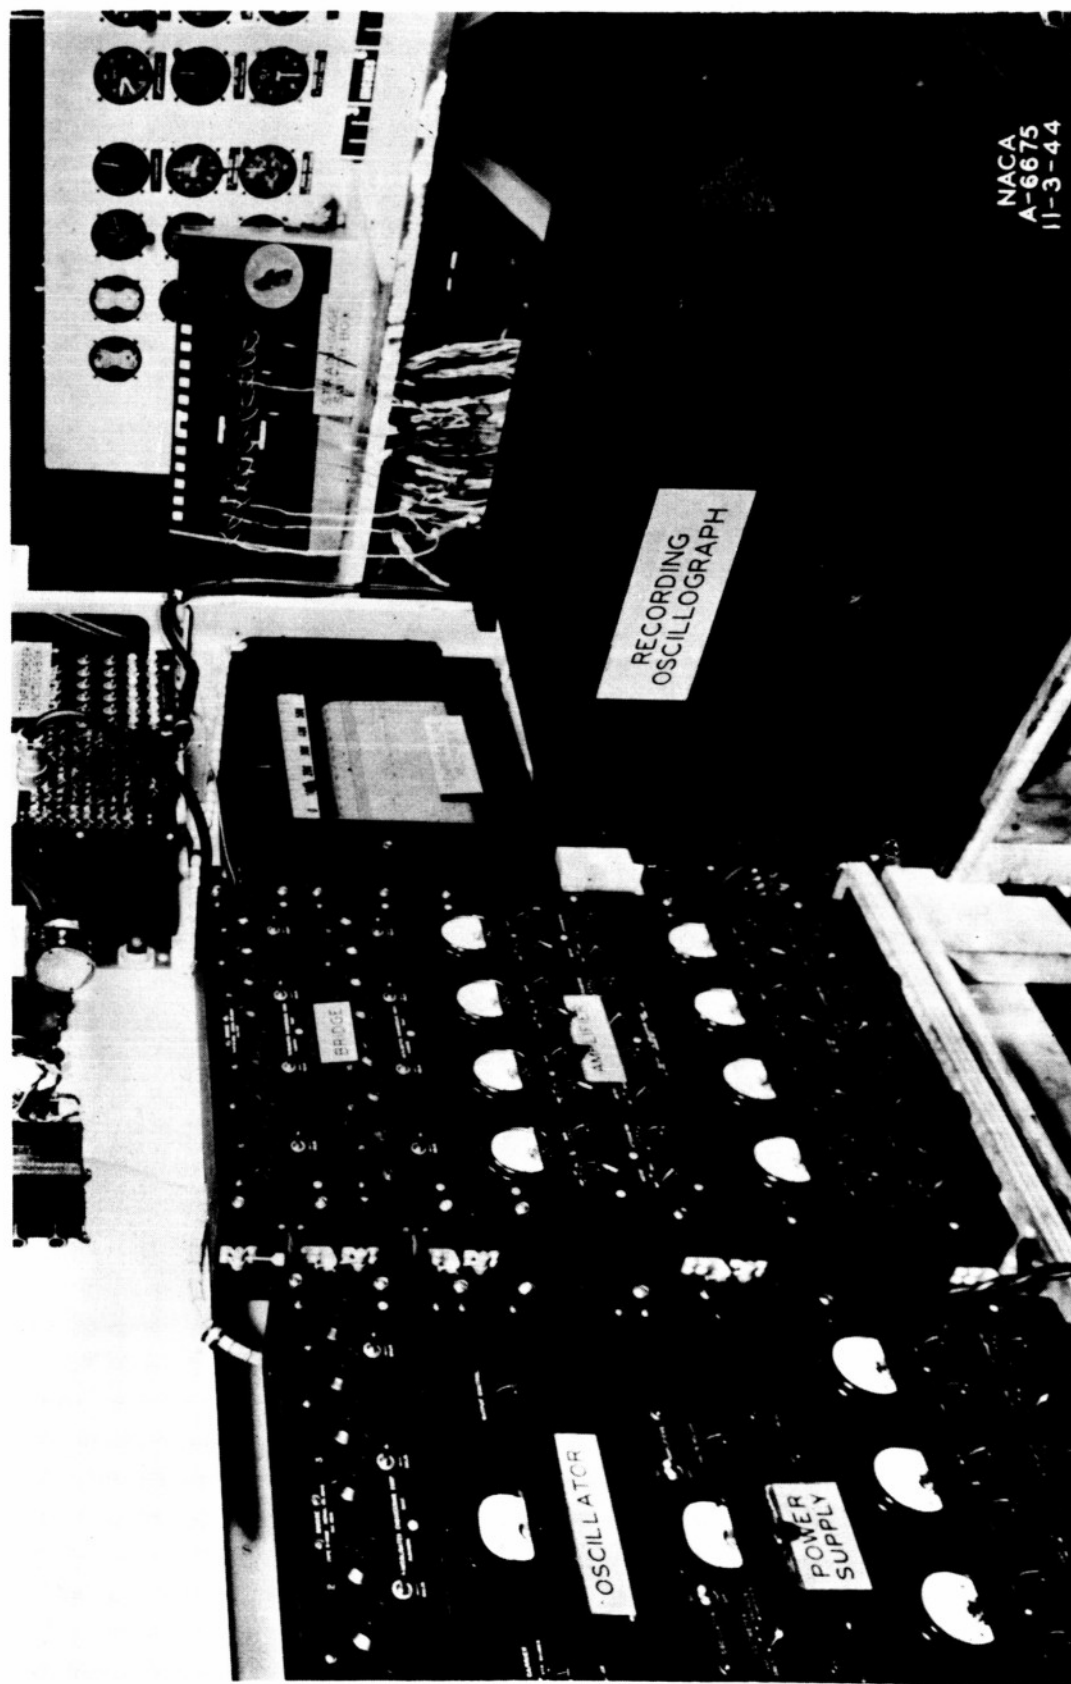
Figure 8.- Installation of instrumentation in airplane cabin for the wing thermal-stress investigation, C-46 airplane.

The strain-gage recording equipment is shown installed in the airplane in figure 8 and consisted basically of a 12-channel oscillograph, three bridges of four channels each, and three amplifiers of four channels each. The strain-gage switch box shown in figure 8 provided a means for connecting any 12 gages at one time to the recording oscillograph. A schematic diagram showing the complete circuit for one channel is presented in figure 9. The active and dummy gages were connected in two arms of a Wheatstone bridge circuit, the remaining two arms consisting of variable resistors in the four-channel

Standard NACA instruments were installed to record airspeed and normal acceleration. An NACA timer, shown installed at the left of the airspeed recorder in figure 8, was used to synchronize the airspeed, accelerometer, and oscillograph records. The accelerometer was installed on the floor of the airplane at the center of gravity and oriented to record accelerations normal to the wing chord at station 0. The airspeed recorder was connected to the service Kollsman airspeed-head installation and the error in static-pressure reading was determined in flight for all the test conditions with a trailing static pressure head.
